# **Your Inspection Report**

# 178 Browning Avenue Toronto, ON M4K 1W5

RE: Report No. 92726 178 Browning Avenue Toronto, ON M4K 1W5

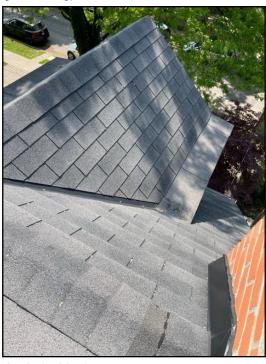
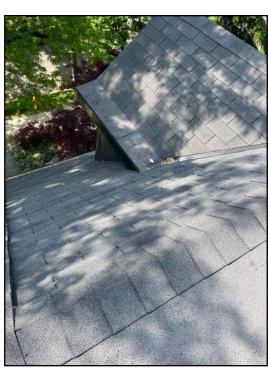
Asphalt shingles

**Condition:** • The roof shingles are in good overall condition.

The roof shingles are in good overall...

Annual inspections are recommended (on any roof) to take care of any roof damage and/or regular maintenance items (flashings/caulking).

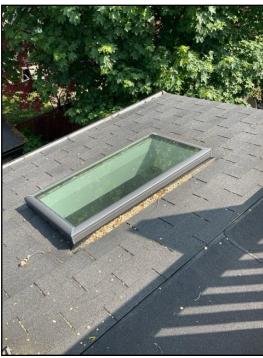
Condition: • Skylight(s) - vulnerable area for leaks

Skylight(s) - vulnerable area -

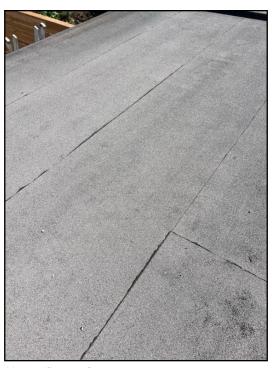
The upper flat roof still has life remaining.

Upper flat roof

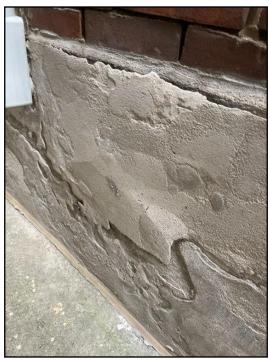
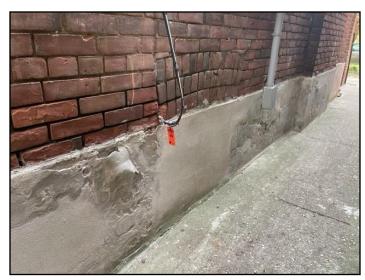
Condition: • Parging damaged or missing

Parging damaged or missing

Time: As soon as practical

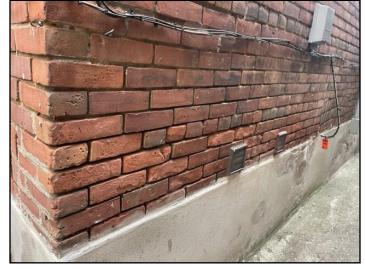
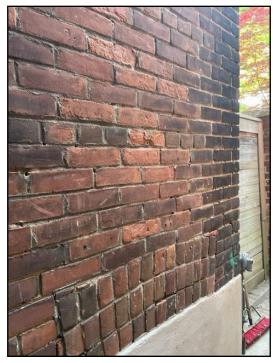
Condition: • Spalling

Spalling

Improve the conditions that caused the spalling in the first place. Rising damp from water infiltration due to poor slope of grade is typically the cause. Previous poor performance of gutters and downspouts also contributes to masonry damage. **Location**: Left (looking from street)

Task: Improve drainage to stop the cause of the spalling and then re-point the mortar joints once it is clear that the moisture has been stopped

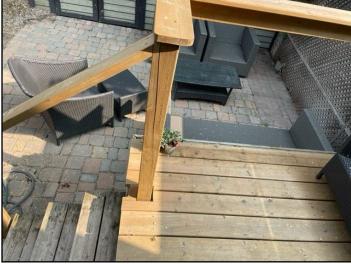
Condition: • Spindles (balusters) missing

Spindles (balusters) missing

Time: As soon as practical

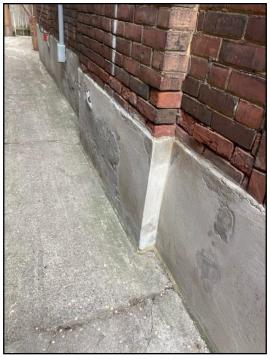
**Condition:** • The ground around some parts of the home does not slope to drain water away from the foundation. Task: Improve grading so the ground slopes down at least 1 inch per foot for the first 6 feet away from the home. Note: Less slope is needed on hard surfaces like driveways

Lot grading

Time: If necessary

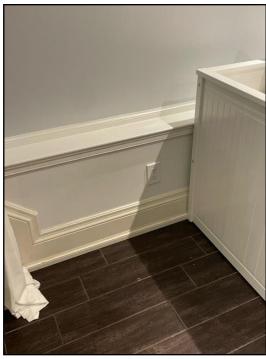
Condition: • Basement lowered

Basement lowered

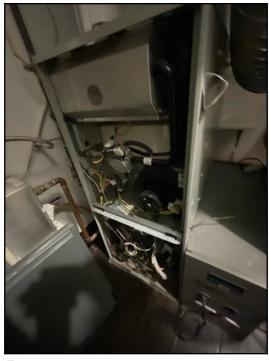
Furnace

Condition: • Near end of life expectancy

Although the furnace is close to the end of its life, continue to use and maintain the unit until it fails. Be prepared to replace the furnace at any time.

Task: Replace

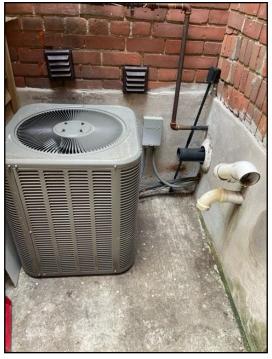
Air cooled

Condition: • Air conditioner near the end of typical life expectancy

Although the air conditioning system is close to the end of its life, continue to use and maintain the unit until it fails. Be prepared to replace at any time.

Task: Replace

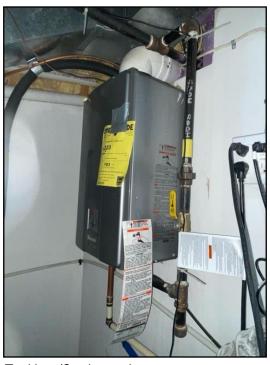
Tankless/On demand

Water heater fuel/energy source: • Gas Water heater approximate age: • 14 years

Condition: • Near end of life expectancy

Task: Replace

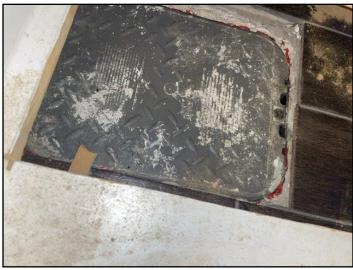
Condition: • Cover not removed

Cover not removed
